**Memo**

Re: M&L Aggregate – Map 41, Lot 13-1  
Stormwater Management Design Review

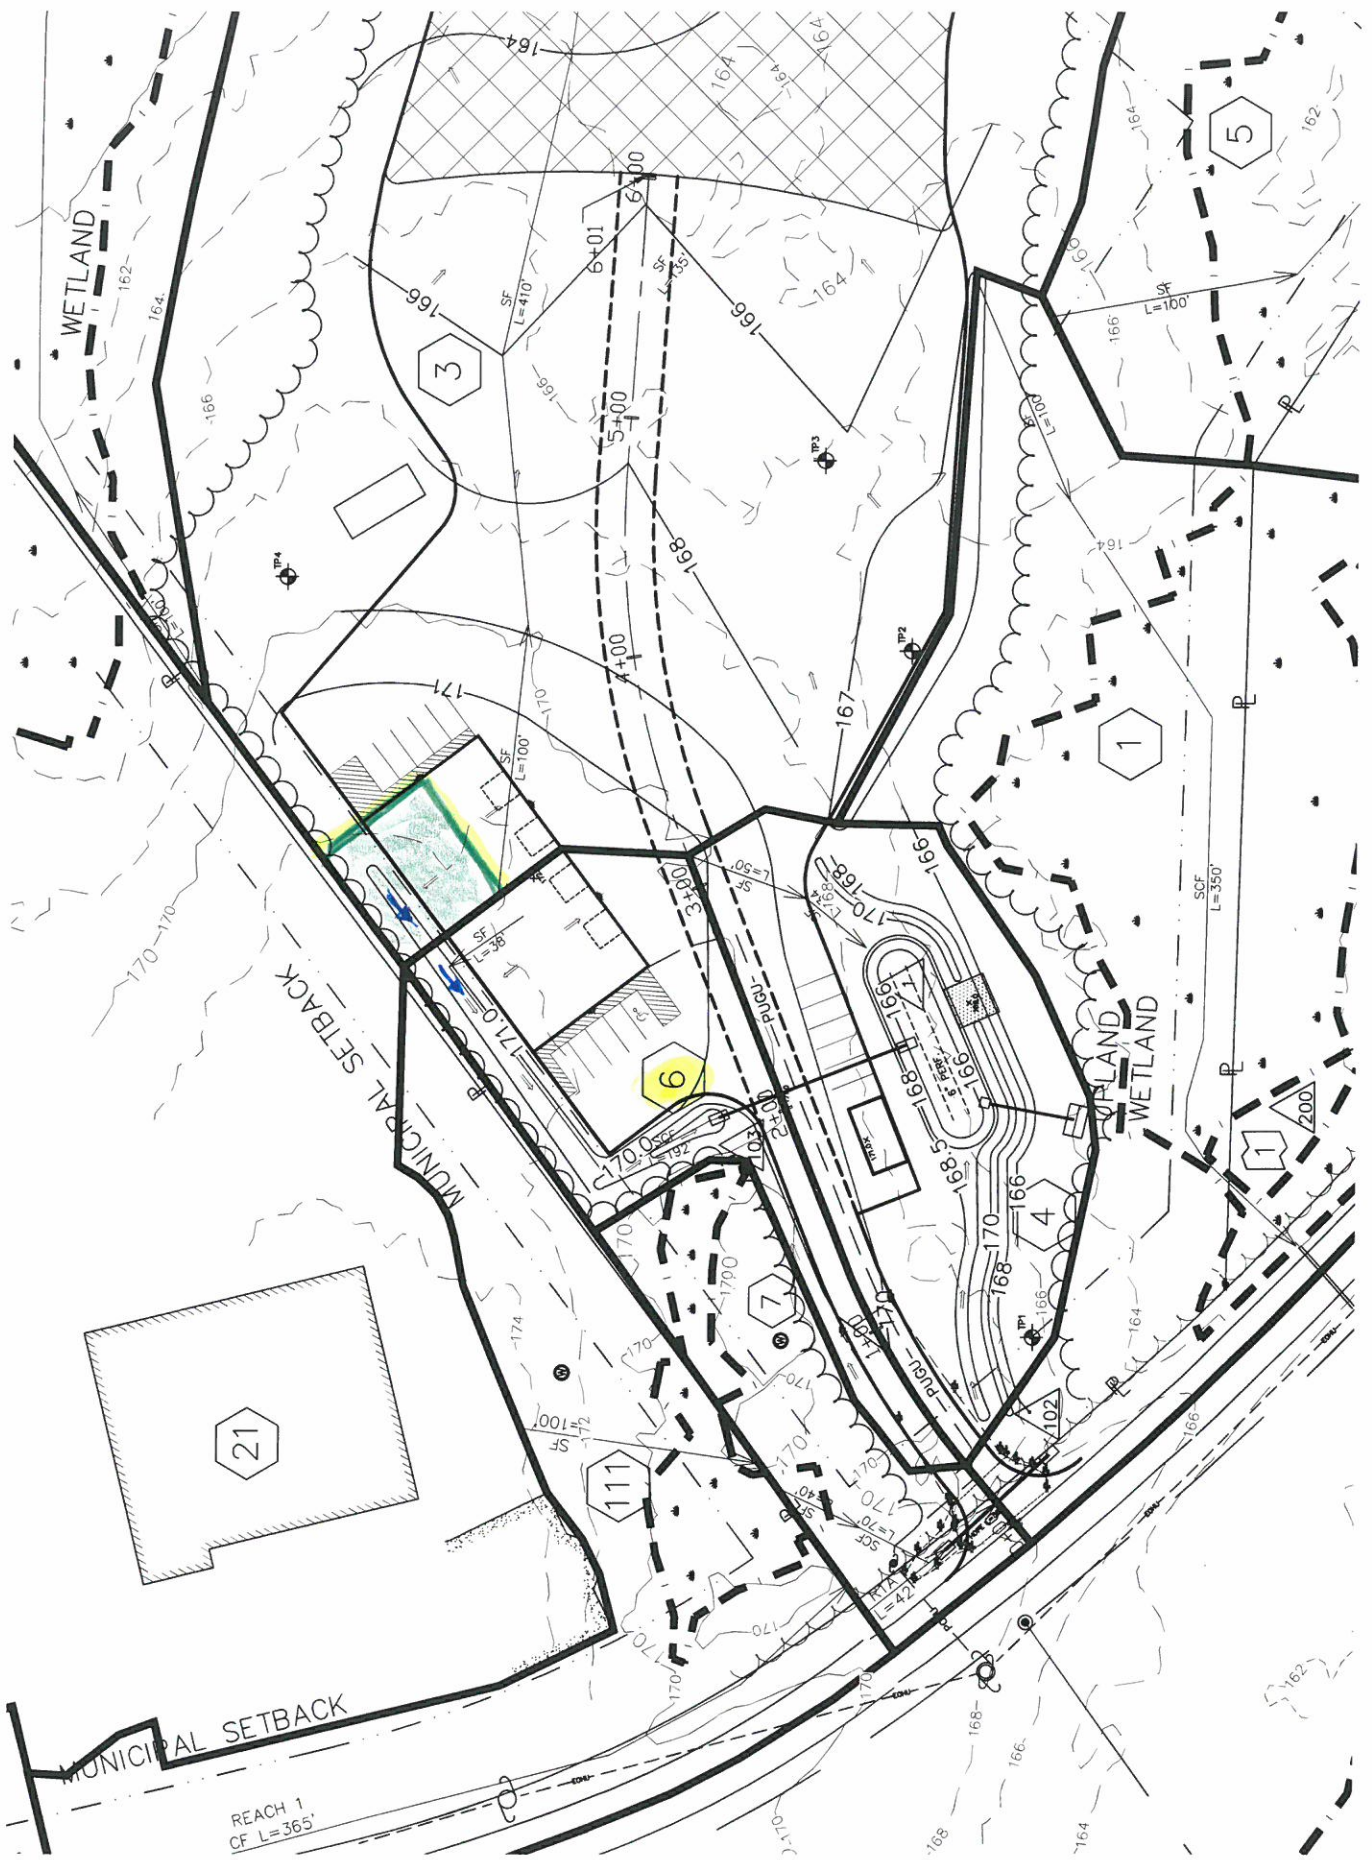
- Subcatchment areas and flow paths good
- Only one area of note on Subc 6 – basin limits should be revised to include back side of the building. Proposed contours depict a swale which would collect stormwater from this area, see highlighted plan portion attached.
